# PROPERTY INSPECTION REPORT FORM

### **ADDITIONAL INFORMATION PROVIDED BY INSPECTOR**

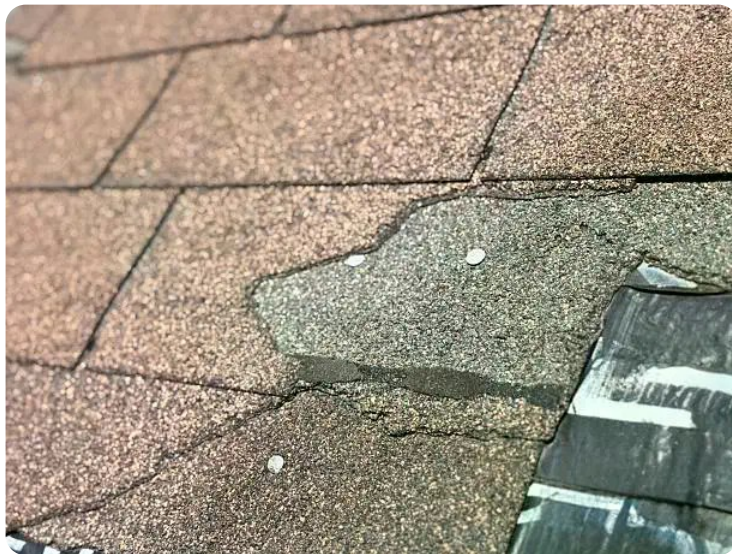
#### Exposed Nails

Under-driven or exposed nails were found in one or more roof coverings. Recommend a qualified roofer evaluate and correct.

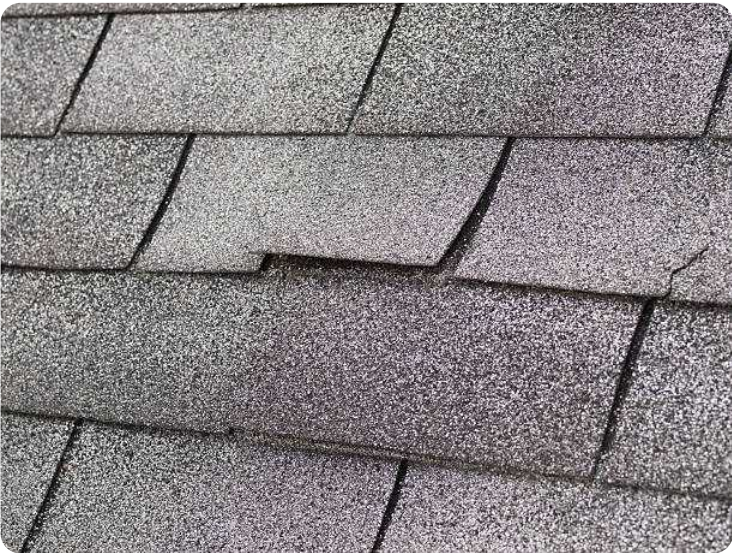
**Cupped shingles**

Shingles cupped up in the center may indicate the shingle is not properly sealed. A new roof which has not yet gone through a hot season. If the cupping has not resolved itself after a summer then the owner should seal these down.

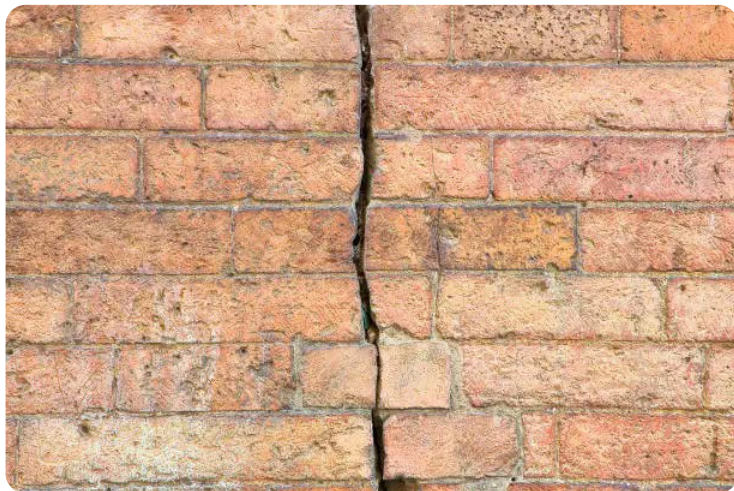
#### Cracks - Major

Major cracking observed in wall structure. This could be from moisture intrusion at the structure and/or soil movement. Recommend a qualified structural engineer evaluate and advise on course of action.

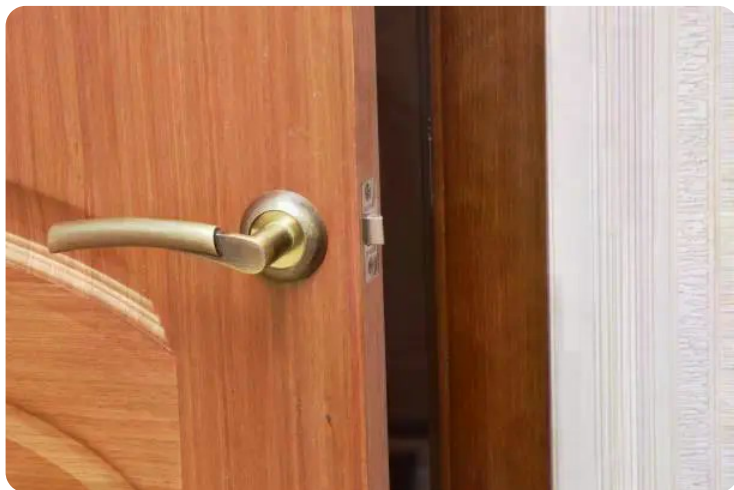
##### Door Doesnt Latch

Door doesn't latch properly. Recommend professional repair latch and/or strike plate.

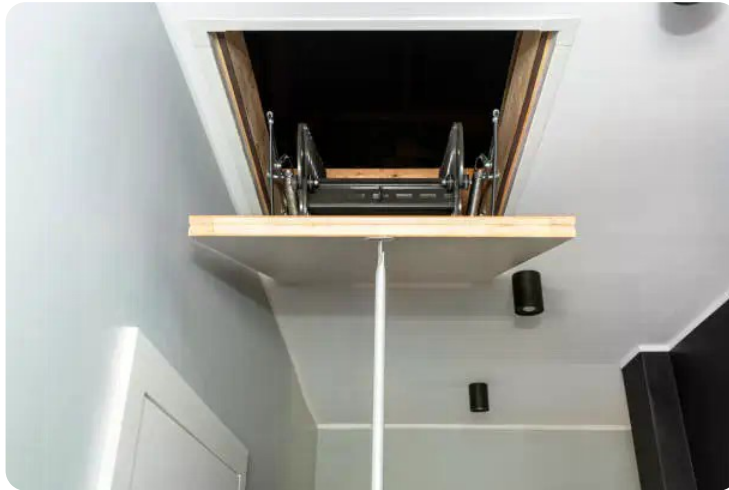
### Stairs don't reach floor

Pull down stairs to garage attic does not reach the floor. Recommend repair prior to close.

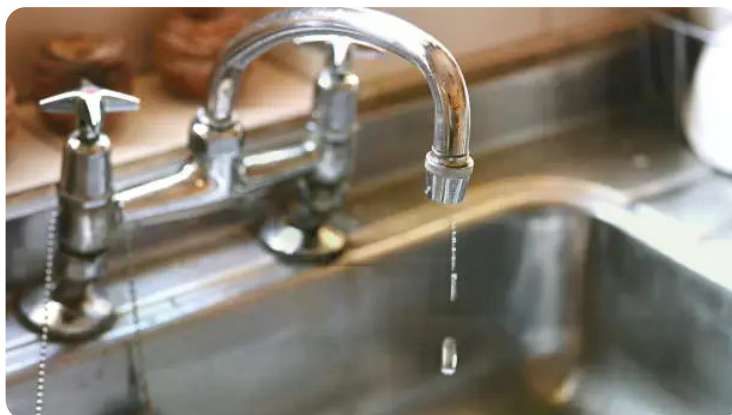
#### Faucet Dripping

A faucet is dripping. Recommend qualified professional or plumber evaluate and repair.
